# OPGW

## OPTICAL GROUND WIRE CABLE

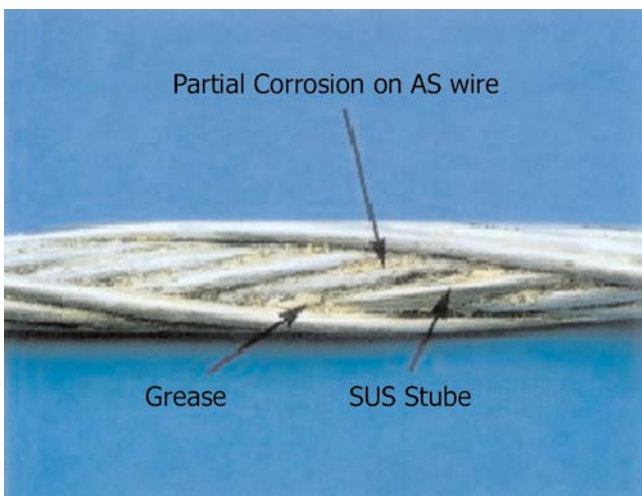
Corrosion between Aluminium armouring wire and steel tube.

The pictures below demonstrate the effect of corrosion between aluminium wires and a steel tube. In the first picture the aluminium clad armouring wires are in constant contact with the steel tube holding the optical fibre. Corrosion can be seen on the wire and can severely compromise the integrity of the cable. The second picture shows that corrosion does not occur between the aluminium tube and the aluminium clad wires, maintaining the integrity of the cable.

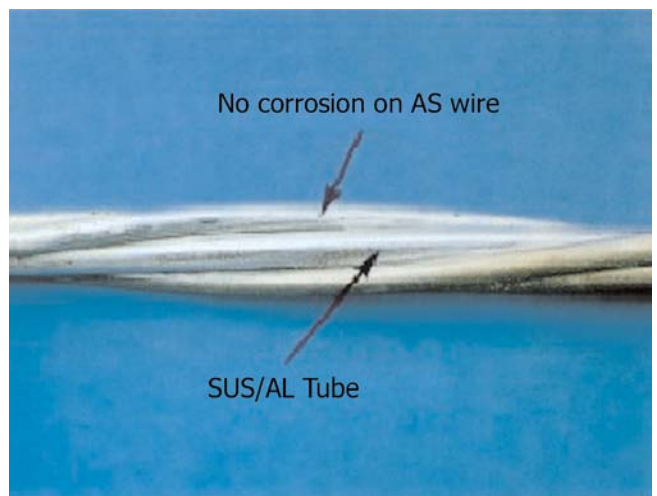
Prysmian OPGW cables do not suffer from corrosion.

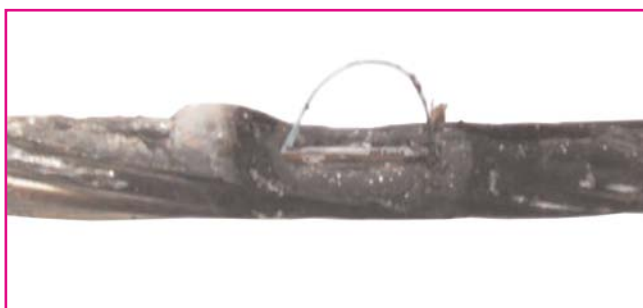
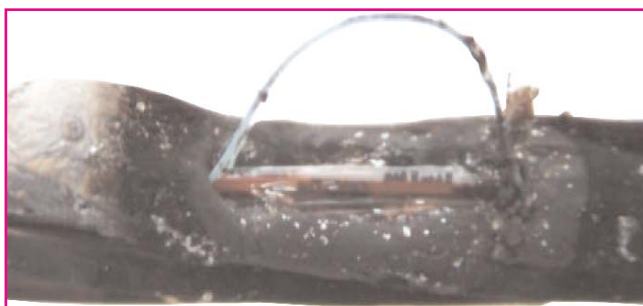
The extensive damage caused by a lightning strike on steel cable. The fibre is exposed and the cable requires replacement.

The pictures below show the effect of a lightning strike upon a steel cable (first picture) and an aluminium cable (second picture).

It can be clearly seen that the steel cable suffers a large amount of damage, exposing the fibre and requiring an expensive replacement.

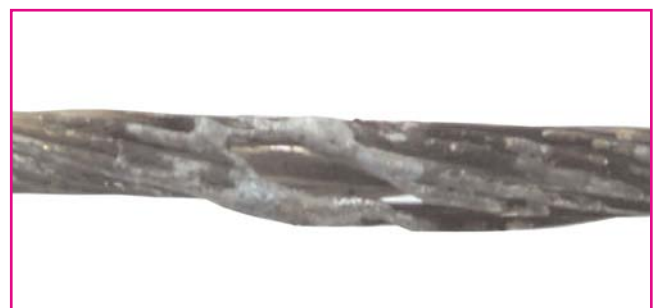
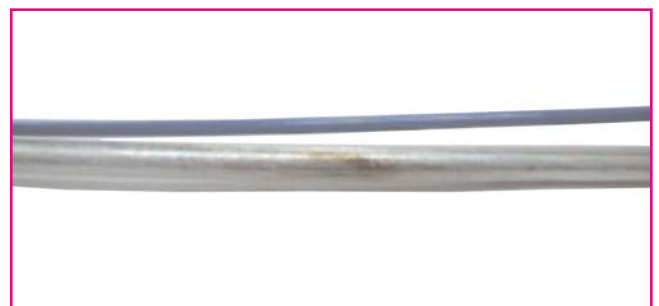
Aluminium cables suffer far less damage when exposed to an identical lightning strike. No damage is caused to the inner aluminium tube or the fibre.

The aluminium cable, despite being struck by an identical lightning strike, suffers far less damage and can be left alone or repaired if necessary. The fibre is fully protected and is not damaged.
